Mobile Intel® Pentium® 4 Processor - M

Specification Update

May 2004

Revision 023

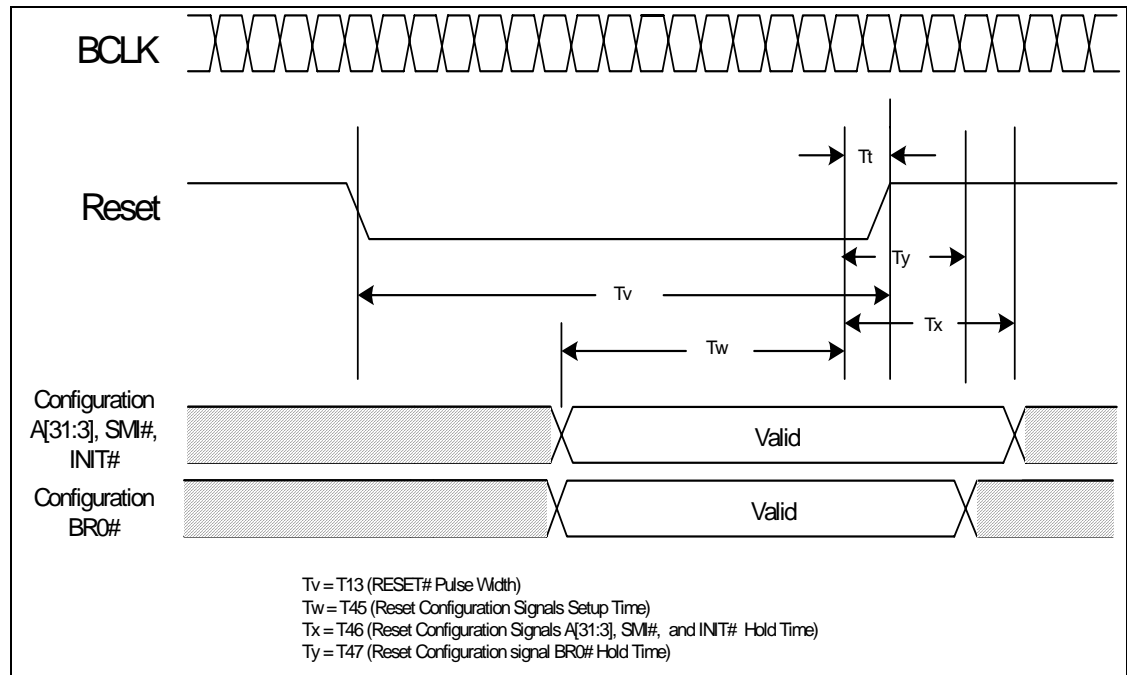
Figure 13. System Bus Reset and Configuration Timings

The BR0# maximum hold time has changed to 2 BCLKs. This change will be shown in the “System Bus AC Specifications (Reset Conditions)” table and “System Bus Reset and Configuration Timings” figure of the *Mobile Intel® Pentium® 4 Processor - M Datasheet*. This change will be incorporated in the next revision of the datasheet.
